Smoke and Dye Testing Summary

High Level Sewershed

Test ID	Test Type	Date Inspected	Company / Super.	Blower MH	Ground Condition	Notification Made?	Total Length
S1028-216	Smoke	8/10/2009	ADS/TM	S19KK_049MH	Dry	Yes	601.72

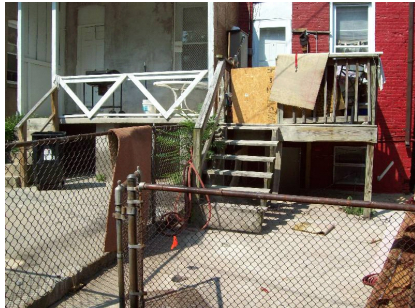
Picture \S1028-216-OB01-P01.jpg

Comments Smoke from cleanout in paved concrete in back yard. 2023 Payson St.

Comments Back of house, 2023 Payson St.

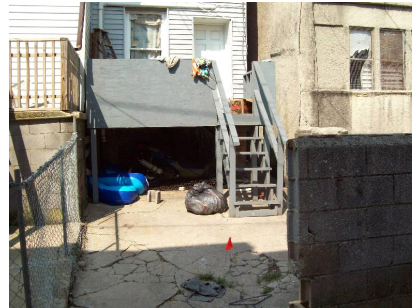
Picture \S1028-216-OB02-P01.jpg

Comments Smoke from cleanout in paved concrete in back yard. 2017 Payson St.

Comments Back of house, 2017 Payson St.

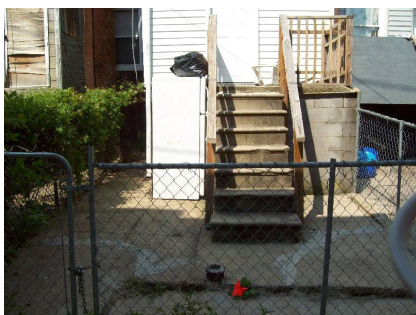
Picture \S1028-216-OB03-P01.jpg

Comments Smoke from above-ground cleanout in paved concrete in back yard. 2015 Payson St.

Comments Back of house, 2015 Payson St.

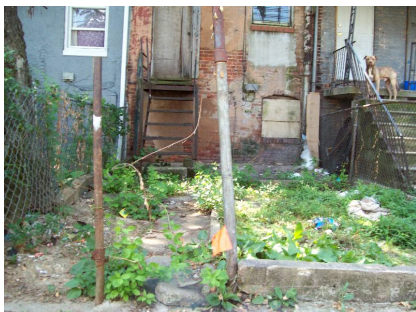
Picture \S1028-216-OB05-P01.jpg

Comments Smoke from cleanout in back yard. 1938 Ridgehill Ave.

Comments Back of house, 1938 Ridgehill Ave.

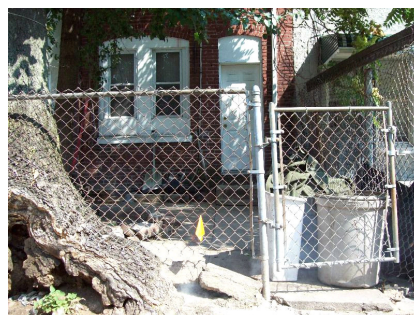
Picture \S1028-216-OB04-P01.jpg

Comments Smoke from cleanout in back yard. 1945 Clifton Ave.

Comments Back of house, 1945 Clifton Ave.

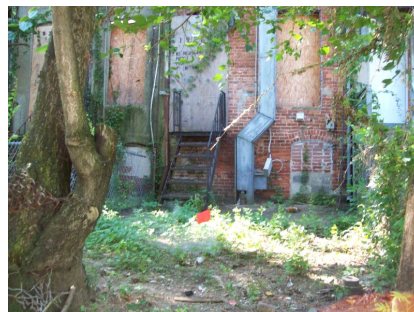
Picture \S1028-216-OB06-P01.jpg

Comments Smoke from cleanout in back yard. 1926 Ridgehill Ave.

Comments Back of house, 1926 Ridgehill Ave.

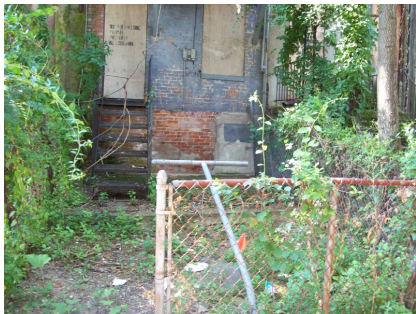
Picture \S1028-216-OB07-P01.jpg

Comments Smoke from cleanout in back yard. 1922 Ridgehill Ave.

Comments Back of house, 1922 Ridgehill Ave.

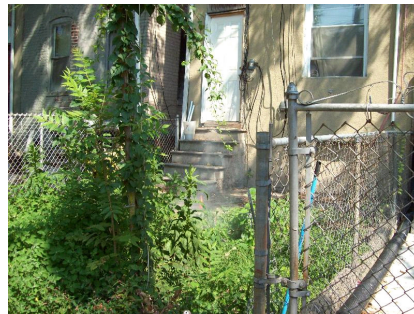
Picture \S1028-216-OB08-P01.jpg

Comments Smoke from cleanout in back yard. 1917 Clifton Ave.

Comments Back of house, 1917 Clifton Ave.
